Intel® Pentium® 4 Processor in the μ PGA Form Factor

Intel Reference Surface-Mount Process

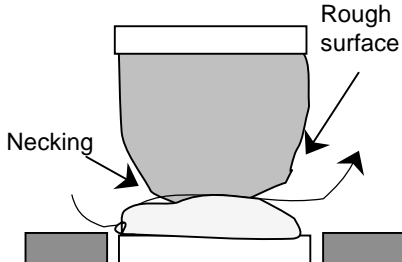
Type	Open Joint Signature	Illustration / Photo	Root cause
A	<ul style="list-style-type: none"> •Cold Solder Joint: Solder paste not reflowing to BGA ball •Appearance of necking with a rough BGA surface •Solder appears grainy and there is a difference between the BGA grain structure and solder paste grain structure (indication that paste did not reach proper reflow temperature)

<ul style="list-style-type: none"> •Low reflow peak temperature •DOE replicated failure signature with peak temp < 190 deg. C
B	<ul style="list-style-type: none"> •Non-solderable interface between PCB pad and BGA ball •PCB pad is not wettable/solderable to the BGA ball due to contamination on pad •Solder paste wetted to BGA ball, but not to PCB pad

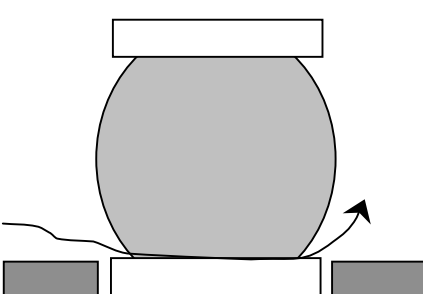
<ul style="list-style-type: none"> •All failures in Intel factories have been due to non-POR rework at our PCB suppliers resulting in contaminated pads with soldermask •Solder pad oxidation, fingerprint contamination, and/or other organic contamination also possible

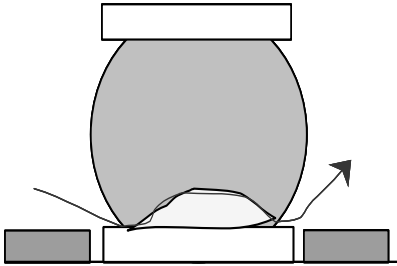
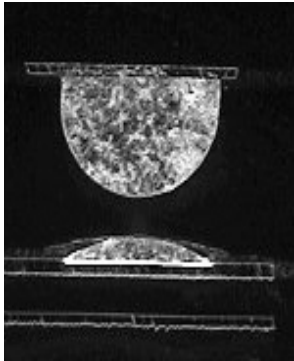
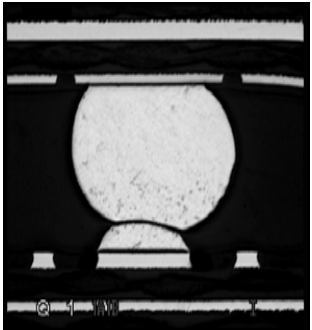
Type	Open Joint Signature	Illustration/ Photo	Root cause
H	<ul style="list-style-type: none"> •Solder paste reflowed properly and wetted to PCB pad •Solder ball reflowed properly and wetted to component pad •Interface between solder paste and BGA ball not wetted •In some cases, failed joints may be associated with elongated or column solder joints adjacent to the signature •Grain structure on board side is similar to BGA ball (properly formed reflowed solder) •Lateral shifting of the BGA with respect to the pad, is also present in some cases

<ul style="list-style-type: none"> •Specific root cause not determined yet •Potential root causes: •Organic contamination on BGA ball surface prior to reflow •Dynamic package warpage during reflow causes separation between the solder ball and solder paste resulting in excess flux at the interface (causing no wetting), or resulting in “no contact” at reflow temperatures
